CITY OF PEORIA HISTORIC SQUARE MASTER PLAN SEPTEMBER 2006

Structure-Moving Feasibility Study
for the

Historic Peoria Jail

Peoria Women's Club

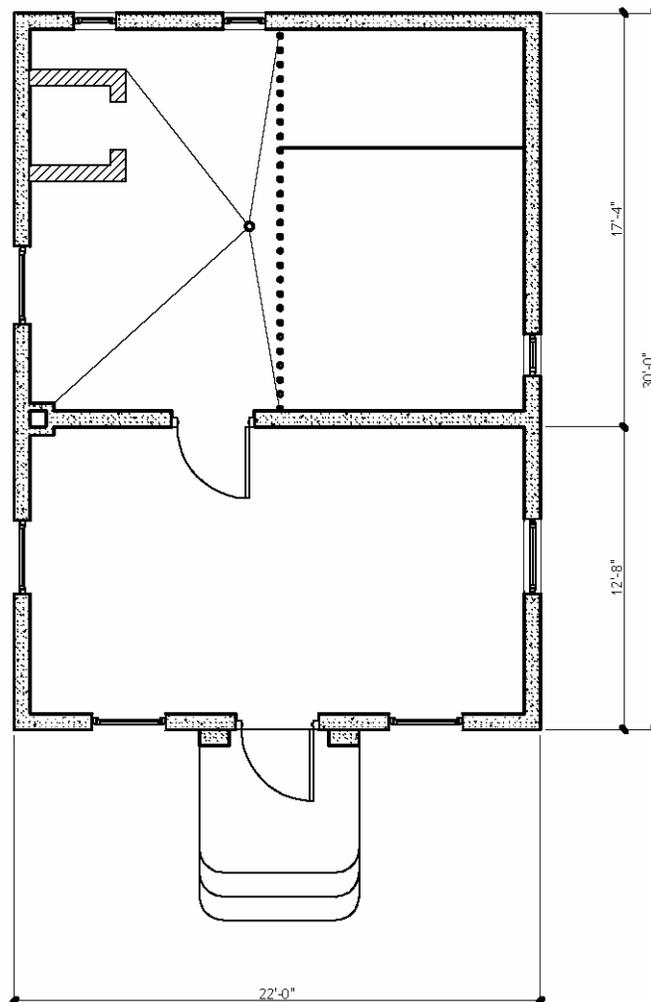
FLOOR PLAN
Scale 1/8" = 1'-0"

The building is of concrete construction throughout. 8" thick concrete walls support a concrete roof deck of unknown thickness. The floor, while raised between 18 inches and 21 inches above surrounding grade, is a concrete slab on fill. There is one interior partition, also of concrete. The foundation was excavated by City personnel, and was found to be resting on a spread footing, approximately 12 inches wide, with bearing at 24 inches below grade. The overall size of the Jail is 22' x 30'. Overall height is about 14'-8", with the parapet being 13'-2" above the floor level. The ceiling inside is 10'-6" above floor level. The building is in excellent overall structural condition.

The only significant interior features are the jail cells, which have their original iron bars and (altered) bunk shelves. A concrete masonry shower was added in the cell room, as was a floor drain, indicating that the concrete floor in this area is likely not the original slab. Most of the original steel casement windows exist in fair condition. The east window of the front office has been altered for a door (to an addition, since removed) and then subsequently stuccoed over to match the surrounding walls.

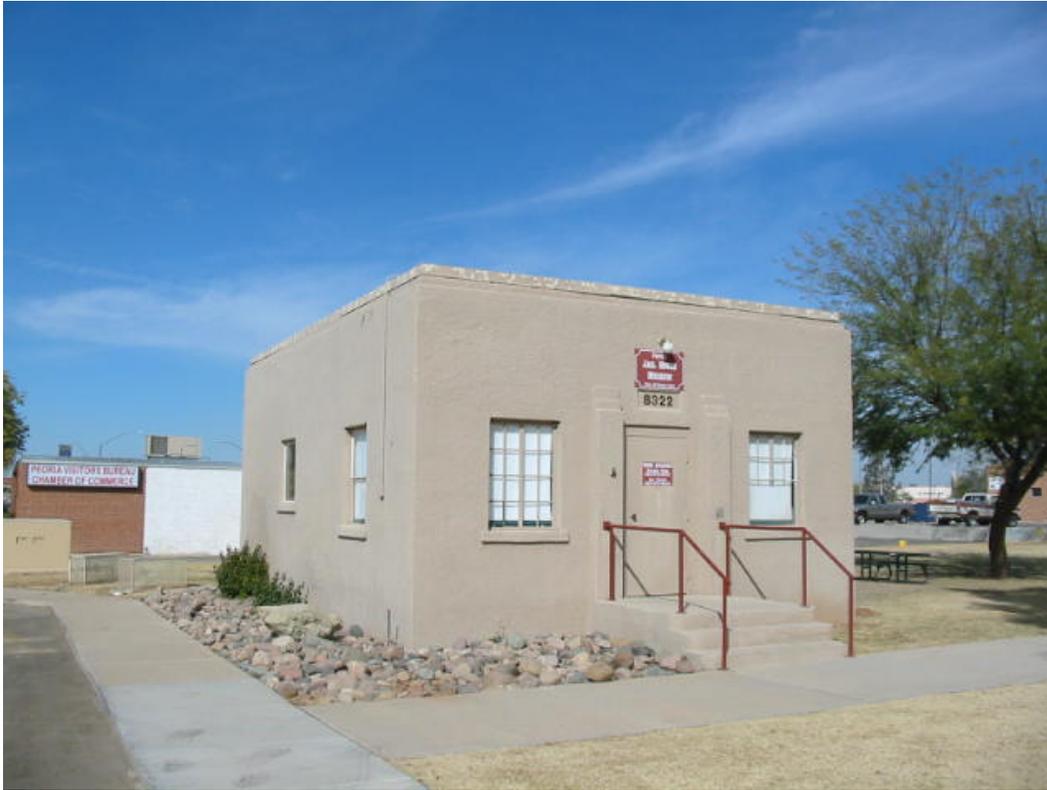
Exterior Overview

Due to the precarious nature of this building and its associated relocation cost, it is recommended that this building remain at its existing location. An estimated relocation cost is provided for reference purposes only.

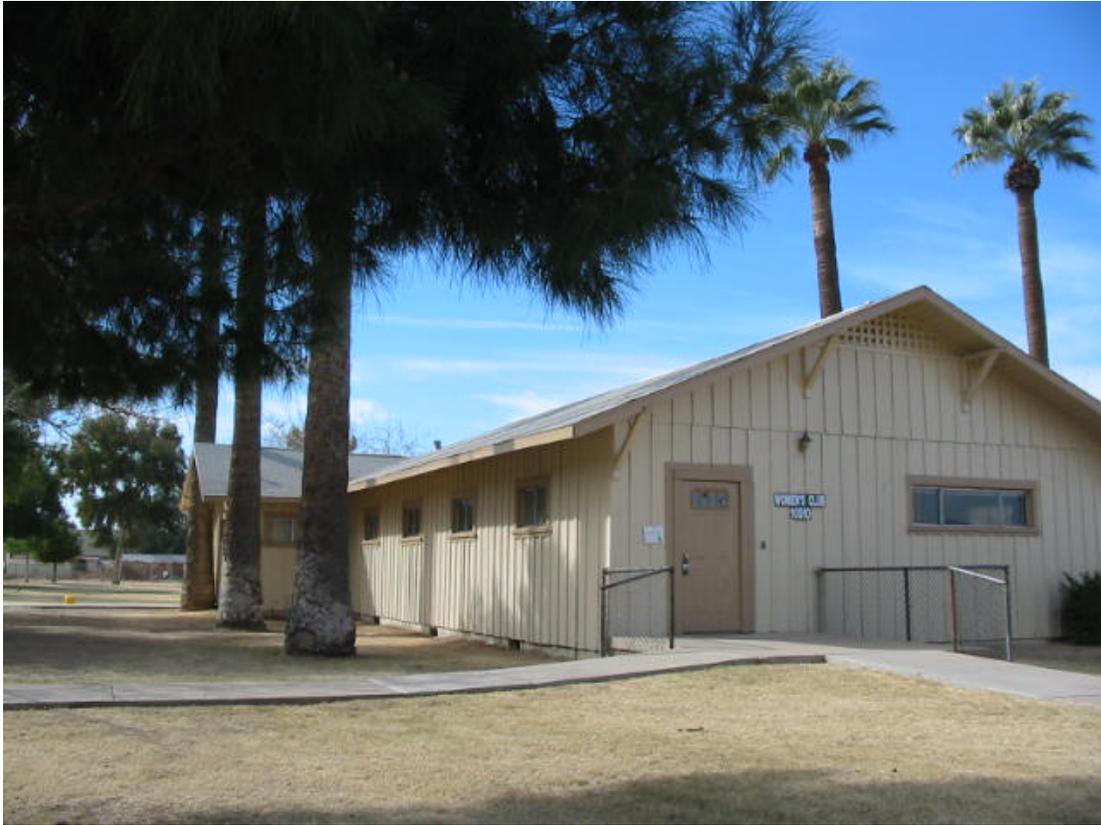
Overview of exterior

The frame walls are in generally good condition. The building has been well maintained and the cedar siding has contributed its longevity. The walls will resist the gravity loads. The walls, as constructed however, will not meet current load requirements for shear walls to resist wind and seismic loads.

Repair of some portions of the walls may be required. Addition of plywood wall sheathing to the interior of the walls is recommended. This method of reinforcement will provide lateral resistance and the opportunity to install shear wall hold downs without disturbing the historic exterior siding.

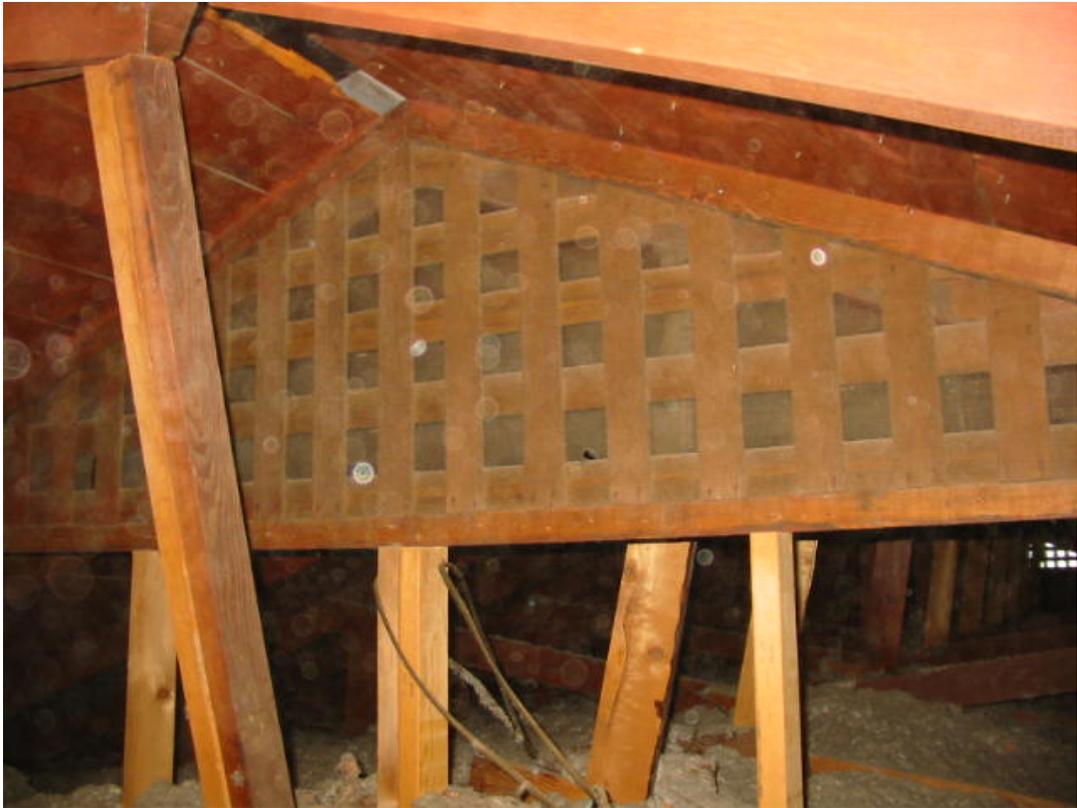
Old vent in the attic indicates one end of the original building

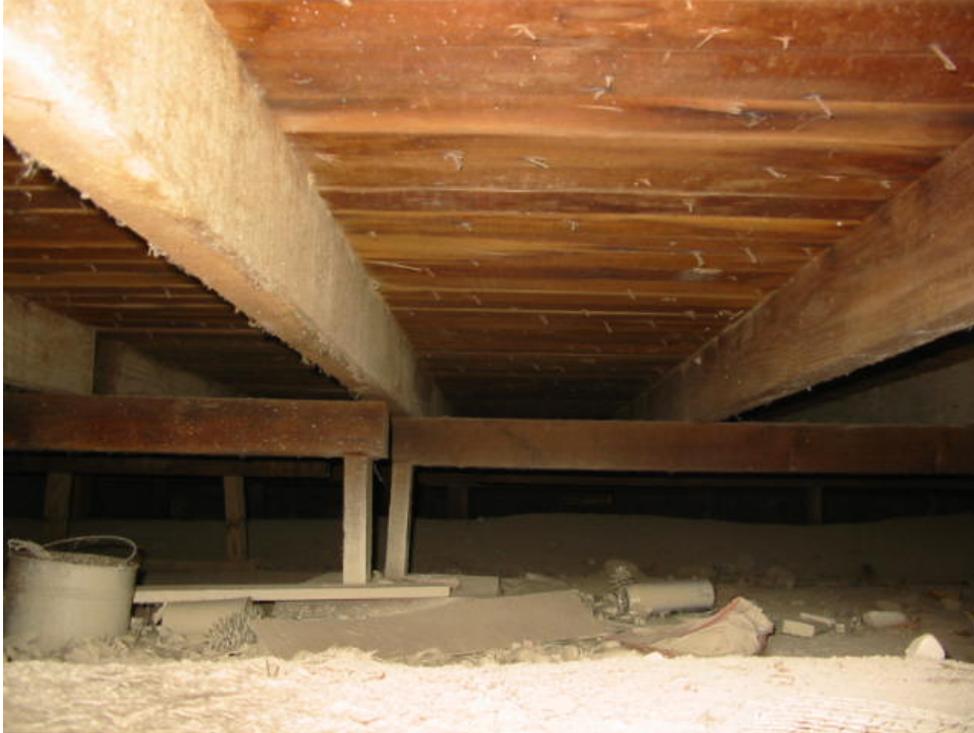
View of the crawlspace

The floor is in generally good condition and free of distress. The intermediate 4x4 beams, however, appear to be over spanned. The floor structure is closer to the earth than the 18 inches prescribed by the Code.

The floor will require reinforcement of the intermediate beams. This can be readily and easily accomplished when the new foundations are placed and the building moved. The existing floor height will need to be raised or the site pad excavated at the new location to accommodate the Code required 18 inch clearance between the earth and the joists.

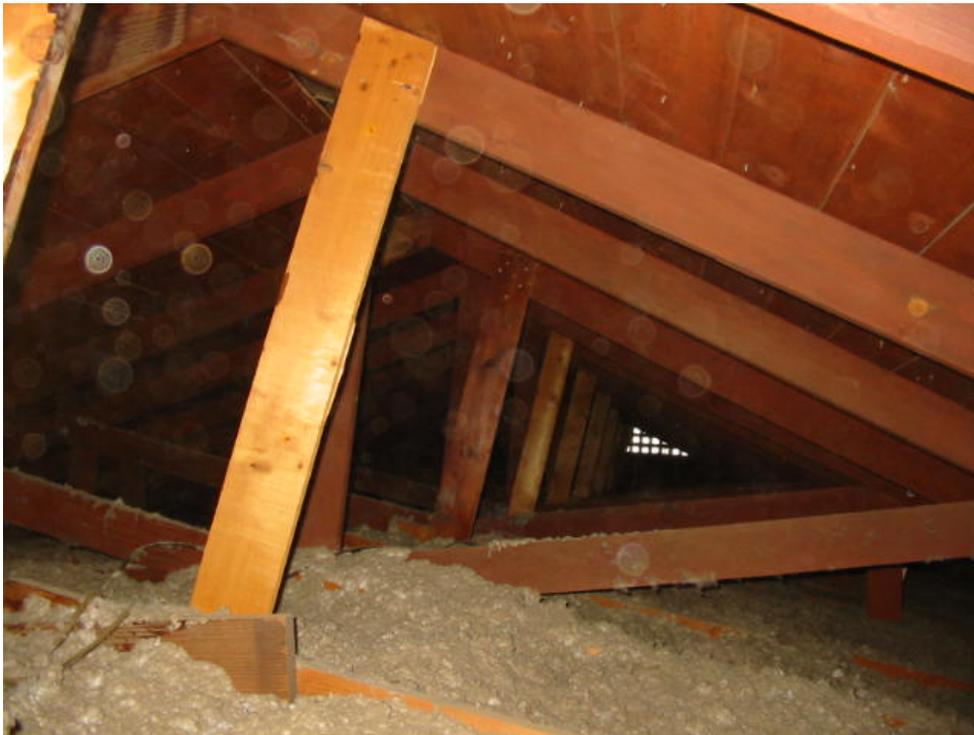
View of the attic

- Roof framing may be over-spanned and improperly detailed. A sag was found in part of the roof that may indicate an overloaded condition or one or more broken framing members. The roof will need to be examined in detail and the loading capacity would need to be calculated. Some level of reinforcing of the roof is anticipated. As a minimum, any broken members will be replaced or spliced and reinforced, the truss connections will be reinforced with through-bolts, and the rafters and trusses will require tying down to the walls. A plywood diaphragm should be added over the roof decking prior to re-roofing the building.

The roof structure is in generally fair shape, however, there are several areas of noticeable sagging in the roof of the original 1919 building. Considering the actual dead load, Code required live loads and the rafter spacing, it appears that the roof joists are over spanned.

The roof structure will require some reinforcement. This reinforcement will be in the form of new bracing and intermediate supports. This reinforcement should be done prior to moving the building.
