# PEORIA FACADE STUDY

## Evolution of the Built Environment

ARIZONA STATE UNIVERSITY  
School of Planning and Landscape Architecture  
May 2003

Prepared for the  
**City of Peoria**  
Community Development Department  
Planning Division

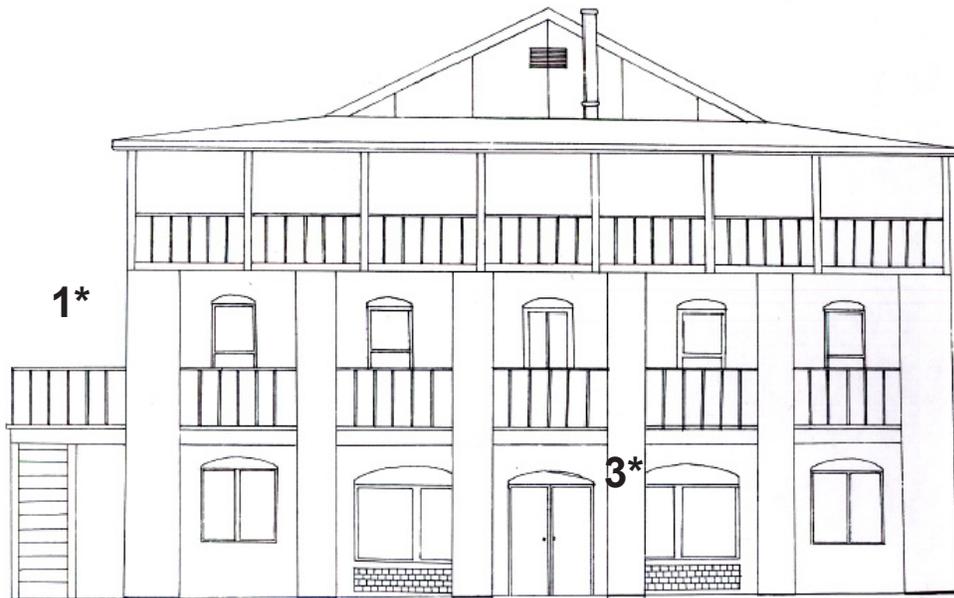
North Elevation

The Edward's Hotel was originally constructed in 1918, after the local newspaper made a plea for someone to build a hotel in the growing little town. The hotel is all that remains of Peoria's boom years from 1917-1929. It is a rectangular three-story building with a gable roof located at the corner of Washington and 84th Drive. Screened sleeping porches were added in the 1920s. Later the building's exterior was sheated in stucco and a two-story arcade was constructed. The historic windows have been infilled and/or replaced with modern ones.

Using physical evidence of original features and historic photographs as a guide, return the building to an earlier appearance.

- 1\*** Dramatic change would occur by removing the arcaded porch supports and replacing with simple posts similar to those used when the sleeping quarters were added in 1925.
- 2\*** A less expensive approach would be reconstructing the historic window openings on the west and north facades.
- 3\*** Reconstruct front entry.

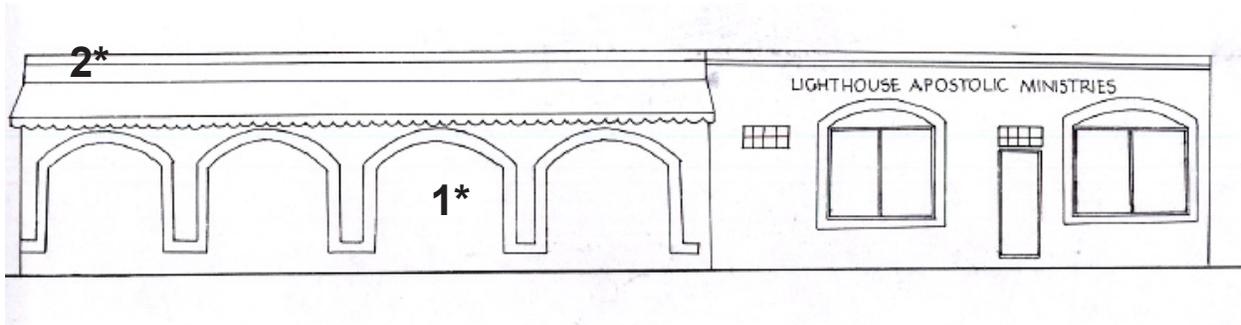
The Lighthouse Apostolic Ministries building is a one-story, flat roof building that was constructed in several stages. The original building on the west was constructed of concrete block. On the front façade a central paneled entry door is flanked by large fixed-pane square windows with segmental arch surrounds that protrude from the wall plane.

The building was expanded to the east with an arcade constructed with segmental arched openings similar to that found on the main building. A shed tile roof extends above the arcade. The westernmost arch is infilled with glass. A door and a square window are located in the front façade of the expansion. The eastern section of the building has stucco walls and a stucco finish was applied to the front façade.

- 1\*** Building arcade of the addition continues the pattern of the existing openings on the original facade.
- 2\*** Space above awning could serve as a sign board.
- 3\*** Infill construction adjacent to the building should be one or two stories in height and have a similar alignment to the street.

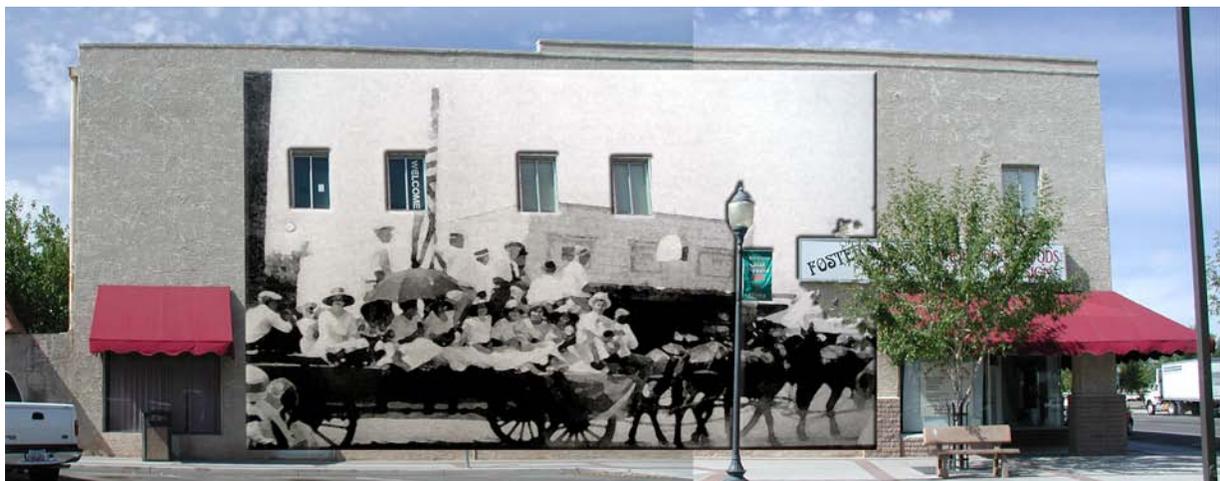
*East View*

The Hood building is a two-story, rectangular building with a flat roof. The front facade has aluminum storefront on the first level covered by an awning. The wall area below the storefront glazing and a portion of the piers dividing the window have been sheathed in dark block. This facade treatment continues around the building corner onto the 83rd Street facade. The building's exterior wall has a stucco finish, and rectangular windows are found along the second story.

The building's appearance can be enhanced by emphasizing the elements that typically characterize historic buildings: the base, the body and the top.

- 1\*** An inexpensive way of detailing the top is to paint a cornice at the flat roof edge.
- 2\*** Adding windows, similar in size and location to the existing windows, would accentuate the pattern created by the 2nd story windows.
- 3\*** A less expensive approach would be to use paint to create elements that reinforce the visual pattern that unites the second level.

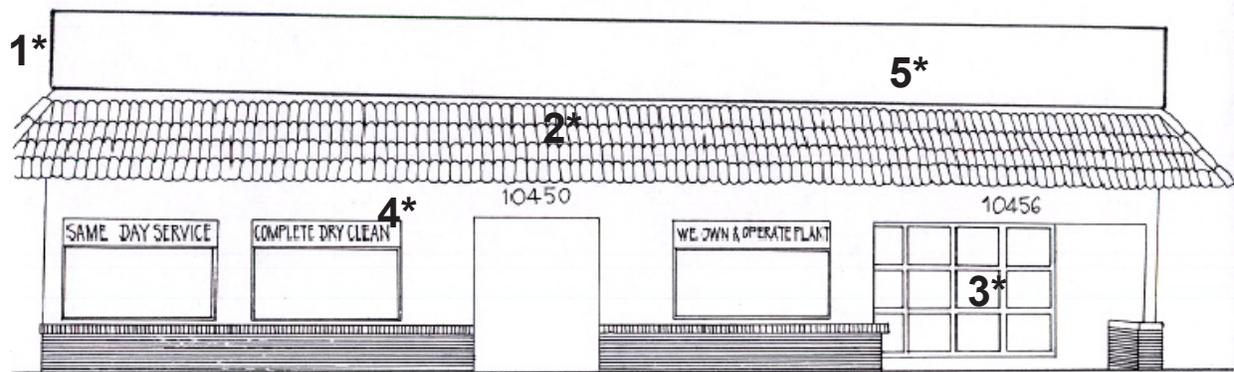
The Peoria Cleaners and Laundry is a one story rectangular building with a flat roof. A parapet wall with a shed tile porch roof extends across the front façade which faces onto 83<sup>rd</sup> Avenue. The parapet wall serves as the primary signboard for the building. The building is constructed of concrete block. Although its original use is not known, it appears that early uses may have been industrial or automobile related because of the configuration of openings on the front façade. When the building was converted to retail use, a recessed bay was infilled with a divided light glass panel and a door. At that time or perhaps later a stucco finish with used-brick and a shed tile porch roof was added.

- 1\*** Building is similar in scale to other structures in downtown.
- 2.\*** Awning continues pattern from awnings established for the block.
- 3\*** Opening has been infilled in a sensitive manner.
- 4\*** Signage is appropriate in size and location.
- 5\*** Parapet wall extruding above flat roof creates a false front that has been historically used throughout the downtown.

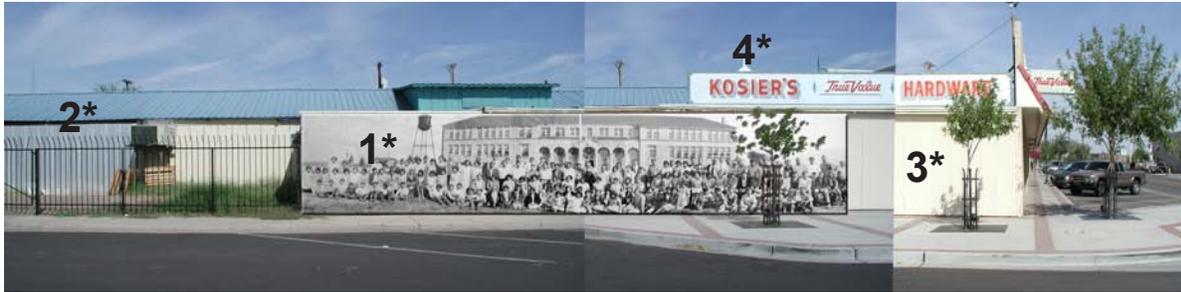
The Kosier Hardware building dates from 1938 and consists of a series of connected structures and additions to the storefront. The buildings are one story with gabled, shed and flat roofs. The primary structures face 83<sup>rd</sup> Avenue and have a false front that extends above a mansard tile roof. The storefront sits on the southern portion of the lot with a large covered storage area extending north to the alley. Slump block piers support the roof in the storage area. The storefront consists of four large display windows and an entrance door. The elevation along Jefferson street consists of a wooden wall without openings.

Maintain existing front facade, as the storefront scale, features and materials continue the pattern found north of the alley on 83<sup>rd</sup>.

- 1\*** Utilize the blank façade for a mural or artwork to enliven the streetscape.
- 2\*** Consider further screening of utilitarian buildings and work yards.
- 3\*** Consider adding window openings on south side.
- 4\*** Remove roof-mounted sign.

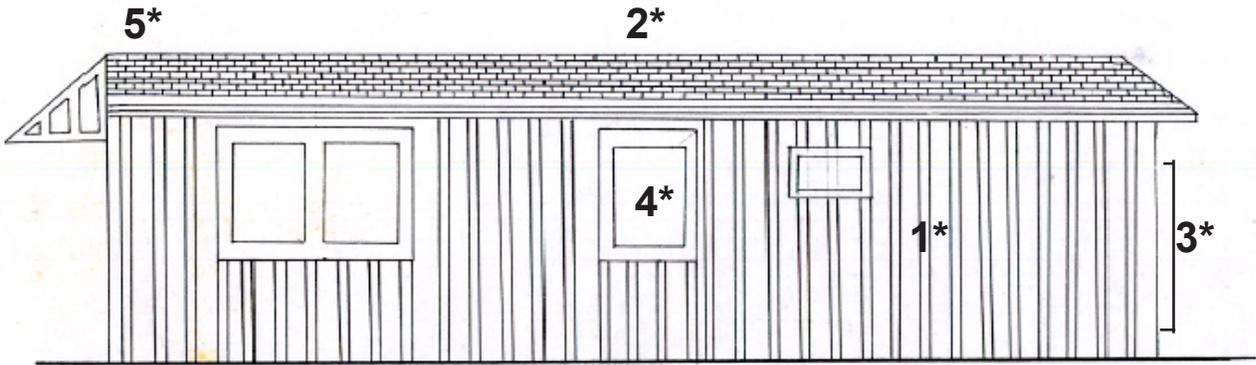
K & E Lock & Key is a onestory frame structure with a gabled roof. A false front is attached to the front façade. Board and batten siding sheathes the building. Battens are painted white. The roof is covered with asphalt shingles that are in poor condition. Residential style windows, both square and rectangular in shape, have simple wood surrounds. Doors are solid panel doors.

Maintenance and repair work should be undertaken to repair the building's deteriorated wood siding and asphalt roof.

- 1\*** Repair deteriorated wood battens and trim.
- 2\*** Reroof with wood shakes or three dimensional shingles to enhance character.
- 3\*** Repaint walls in one color. Use similar color to eliminate striped effect of contrasting batten.
- 4\*** Consider painting window and door surrounds in similar color as body of the building but in a darker hue and removing window bars.
- 5\*** Remove roof-mounted sign.

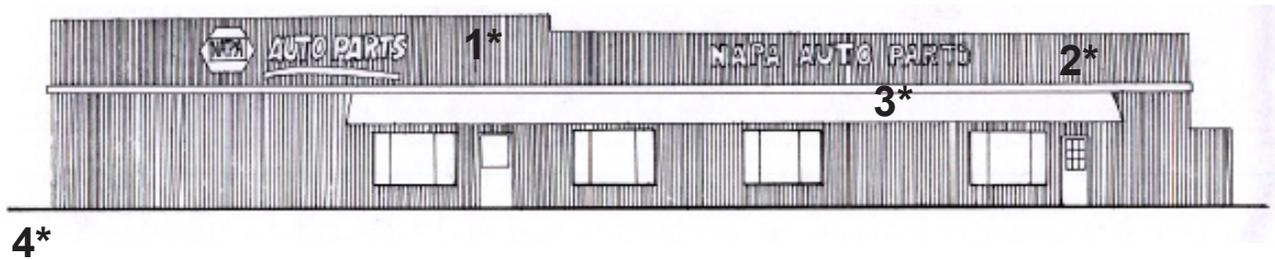
NAPA Auto Parts is a modern utilitarian building which fronts on 83<sup>rd</sup> Avenue and extends almost half a block. The structure is one story and laid out in a simple rectangular form. Corrugated metal sheathes the building's exterior. Like many of the older buildings in the downtown, a parapet wall extends above the roofline creating a false front with a simple step dividing it into two sections. The business signage is attached to the false front. Display windows punctuate the front façade and flank the single leaf entry door. Both the main entrance and an ancillary door have glazing in their upper panel. A metal awning extends across the front façade shading the door and window openings.

This simple functional building is similar to those built during early eras in terms of scale and materials. Its larger size and mass is indicative of modern day warehouse and retailing operations.

- 1\*** The false front gives the building a greater street presence and provides space for signage.
- 2\*** Applied lettering directly on the parapet wall is similar to that found on nearby buildings
- 3\*** Awning is similar in size and location to other building awnings on 83<sup>rd</sup> Avenue.
- 4\*** Painting the body of the building in a more neutral color would blend the structure into its surroundings.

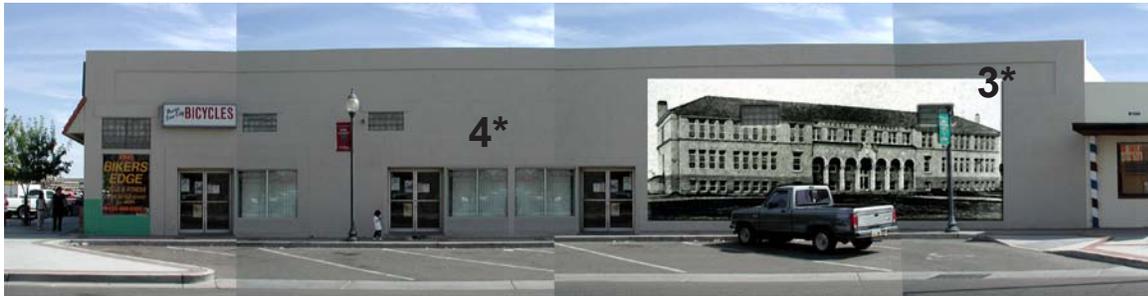
*West View*

Sometime in the 1960s or 1970s the front facades of the different buildings were covered with a new uniform facade that joined the buildings together. Aluminum windows and doors replaced the earlier storefront assemblies. A tile awning was erected above the entrances and a masonry wainscot was installed below the display windows. The wall above the base was covered with stucco.

Building is sound and in good repair. The existing scale, features and materials should be maintained.

- 1\*** Consider replacing existing signage with similar size signs, lettering and features over each business.
- 2\*** Limit signage painted on windows to 10% of the exposed area.
- 3\*** Use expansive flat surfaces for murals or artwork.
- 4\*** Consider installing additional storefronts along 83rd Avenue for retail establishments.
