FIGURE 5-4
 LAND SUBSIDENCE IN PART OF THE WESTERN SALT RIVER VALLEY, 1957-1991

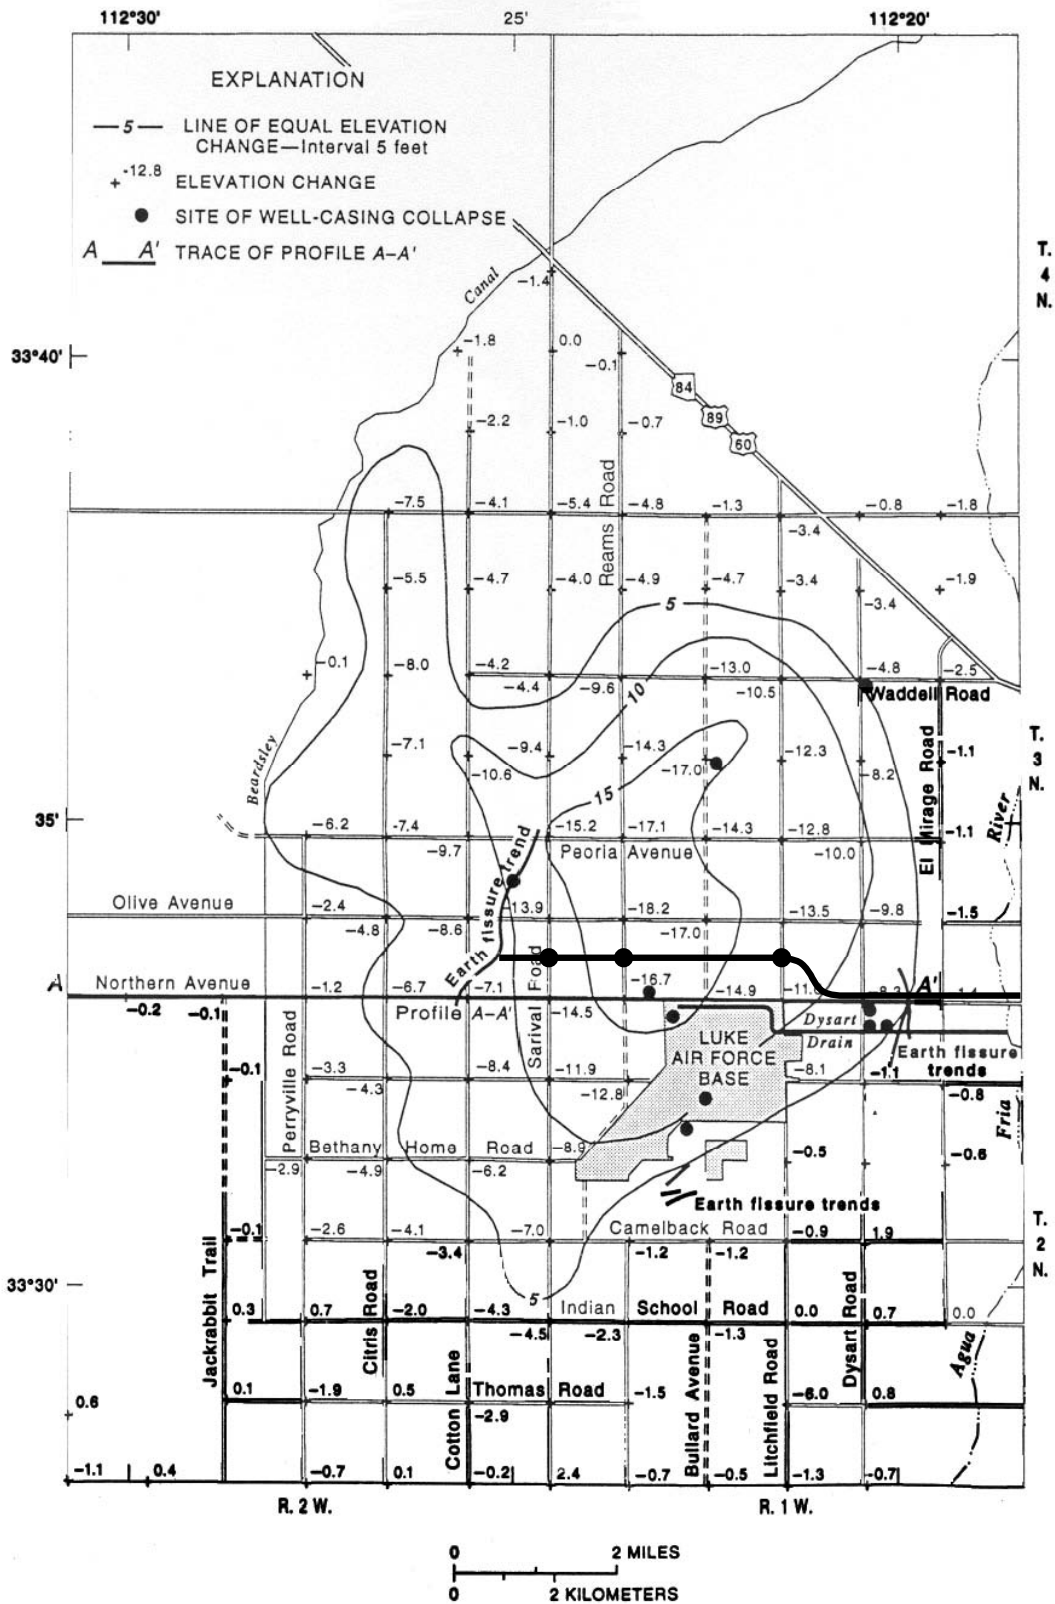
Reference: Base map from U.S. Department of the Interior, U.S.G.S.,
 Administrative Report; Investigation of Hydrogeology, Land Subsidence,
 and Earth Fissures, Luke Air Force Base, Arizona, 1995.
