# PEORIA FACADE STUDY

## Evolution of the Built Environment

ARIZONA STATE UNIVERSITY  
School of Planning and Landscape Architecture  
May 2003

Prepared for the  
**City of Peoria**  
Community Development Department  
Planning Division

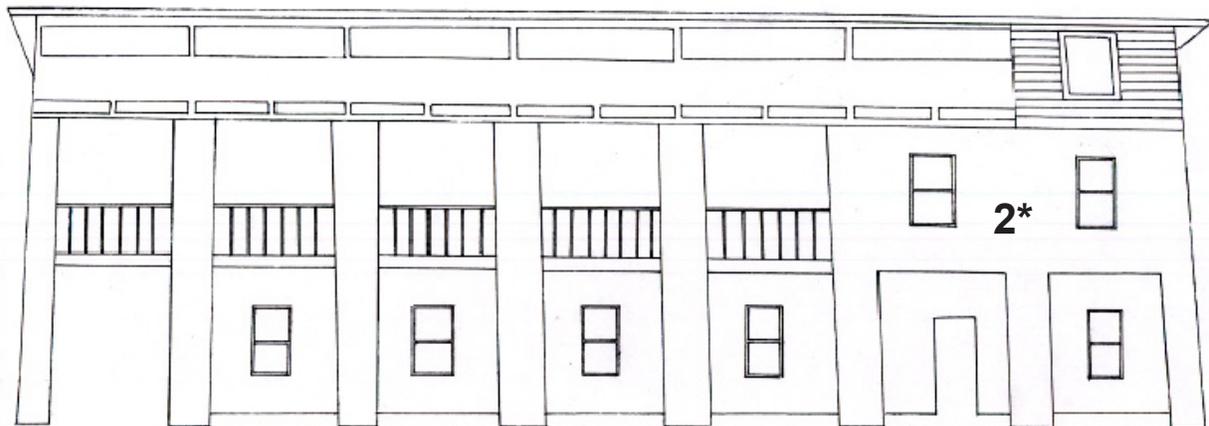
West Elevation

The Edward's Hotel was originally constructed in 1918, after the local newspaper made a plea for someone to build a hotel in the growing little town. The hotel is all that remains of Peoria's boom years from 1917-1929. It is a rectangular three-story building with a gable roof located at the corner of Washington and 84th Drive. Screened sleeping porches were added in the 1920s. Later the building's exterior was sheated in stucco and a two-story arcade was constructed. The historic windows have been infilled and/or replaced with modern ones.

Using physical evidence of original features and historic photographs as a guide, return the building to an earlier appearance.

- 1\*** Dramatic change would occur by removing the arcaded porch supports and replacing with simple posts similar to those used when the sleeping quarters were added in 1925.
- 2\*** A less expensive approach would be reconstructing the historic window openings on the west and north facades.
- 3\*** Reconstruct front entry.

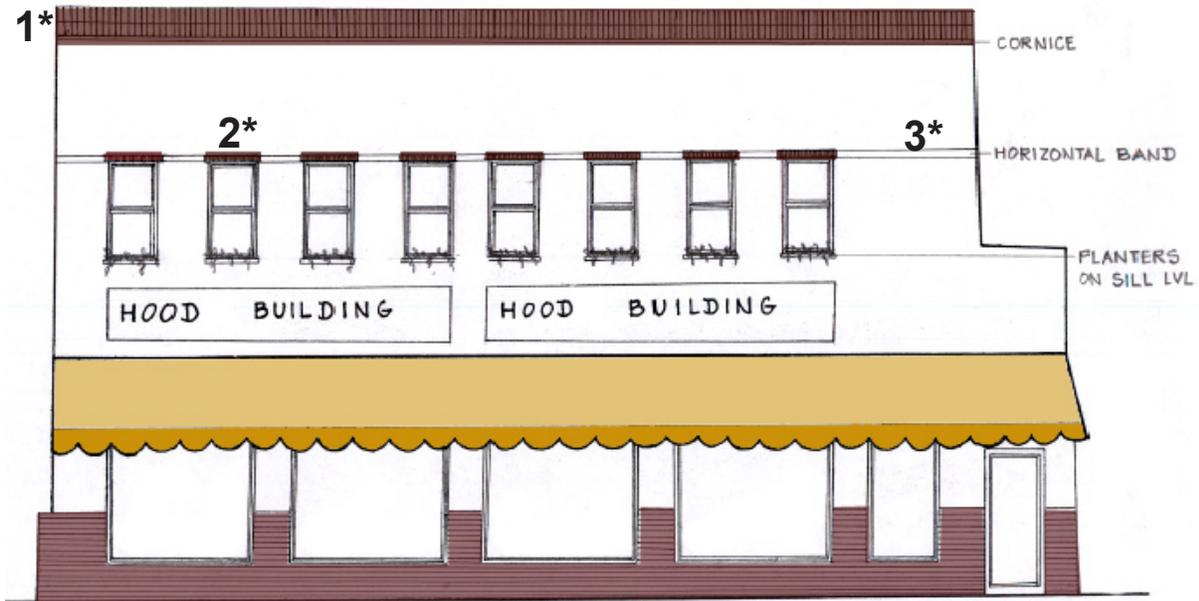
The Hood building is a two-story, rectangular building with a flat roof. The front facade has aluminum storefront on the first level covered by an awning. The wall area below the storefront glazing and a portion of the piers dividing the window have been sheathed in dark block. This facade treatment continues around the building corner onto the 83rd Street facade. The building's exterior wall has a stucco finish, and rectangular windows are found along the second story.

The building's appearance can be enhanced by emphasizing the elements that typically characterize historic buildings: the base, the body and the top.

- 1\*** An inexpensive way of detailing the top is to paint a cornice at the flat roof edge.
- 2\*** Adding windows, similar in size and location to the existing windows, would accentuate the pattern created by the 2nd story windows.
- 3\*** A less expensive approach would be to use paint to create elements that reinforce the visual pattern that unites the second level.

**REHABILITATION TIP**  
The large flat expanse of the secondary facade offer opportunities for murals or other artwork that can enliven the streetscape.

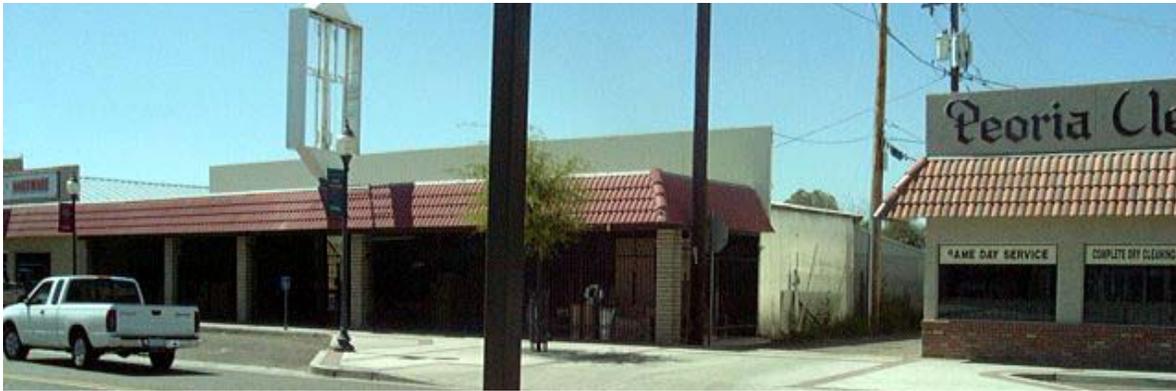
*East View*

The Peoria Cleaners and Laundry is a one story rectangular building with a flat roof. A parapet wall with a shed tile porch roof extends across the front façade which faces onto 83<sup>rd</sup> Avenue. The parapet wall serves as the primary signboard for the building. The building is constructed of concrete block. Although its original use is not known, it appears that early uses may have been industrial or automobile related because of the configuration of openings on the front façade. When the building was converted to retail use, a recessed bay was infilled with a divided light glass panel and a door. At that time or perhaps later a stucco finish with used-brick and a shed tile porch roof was added.

- 1\*** Building is similar in scale to other structures in downtown.
- 2.\*** Awning continues pattern from awnings established for the block.
- 3\*** Opening has been infilled in a sensitive manner.
- 4\*** Signage is appropriate in size and location.
- 5\*** Parapet wall extruding above flat roof creates a false front that has been historically used throughout the downtown.

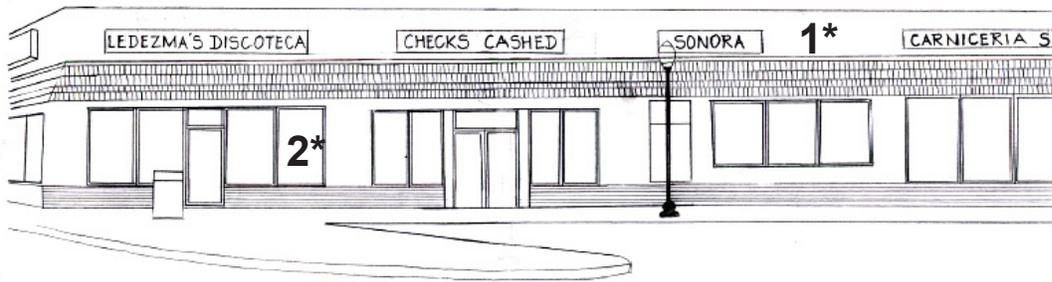
*West View*

Located at the juncture of three streets, this area has housed commercial structures throughout the downtown's development. Initially, the site had simple freestanding structures with flat roofs. As time progressed, additional buildings constructed of concrete block were added to the site to create a continuous row of storefronts. Typical of the mid twentieth century storefronts, these buildings have "open fronts" or "visual fronts." Large display windows were mounted flush with the front facade allowing the interior of the store to be displayed, or in a manner extending beyond the front window zone. Also indicative of the automobile orientation of these retail establishments is the convenient front parking.

Sometime in the 1960s or 1970s the front facades of the different buildings were covered with a new uniform facade that joined the buildings together. Aluminum windows and doors replaced the earlier storefront assemblies. A tile awning was erected above the entrances and a masonry wainscot was installed below the display windows. The wall above the base was covered with stucco.

Building is sound and in good repair. The existing scale, features and materials should be maintained.
