CITY OF PEORIA HISTORIC SQUARE MASTER PLAN SEPTEMBER 2006

Structure-Moving Feasibility Study
for the

Historic Peoria Jail

Peoria Women's Club

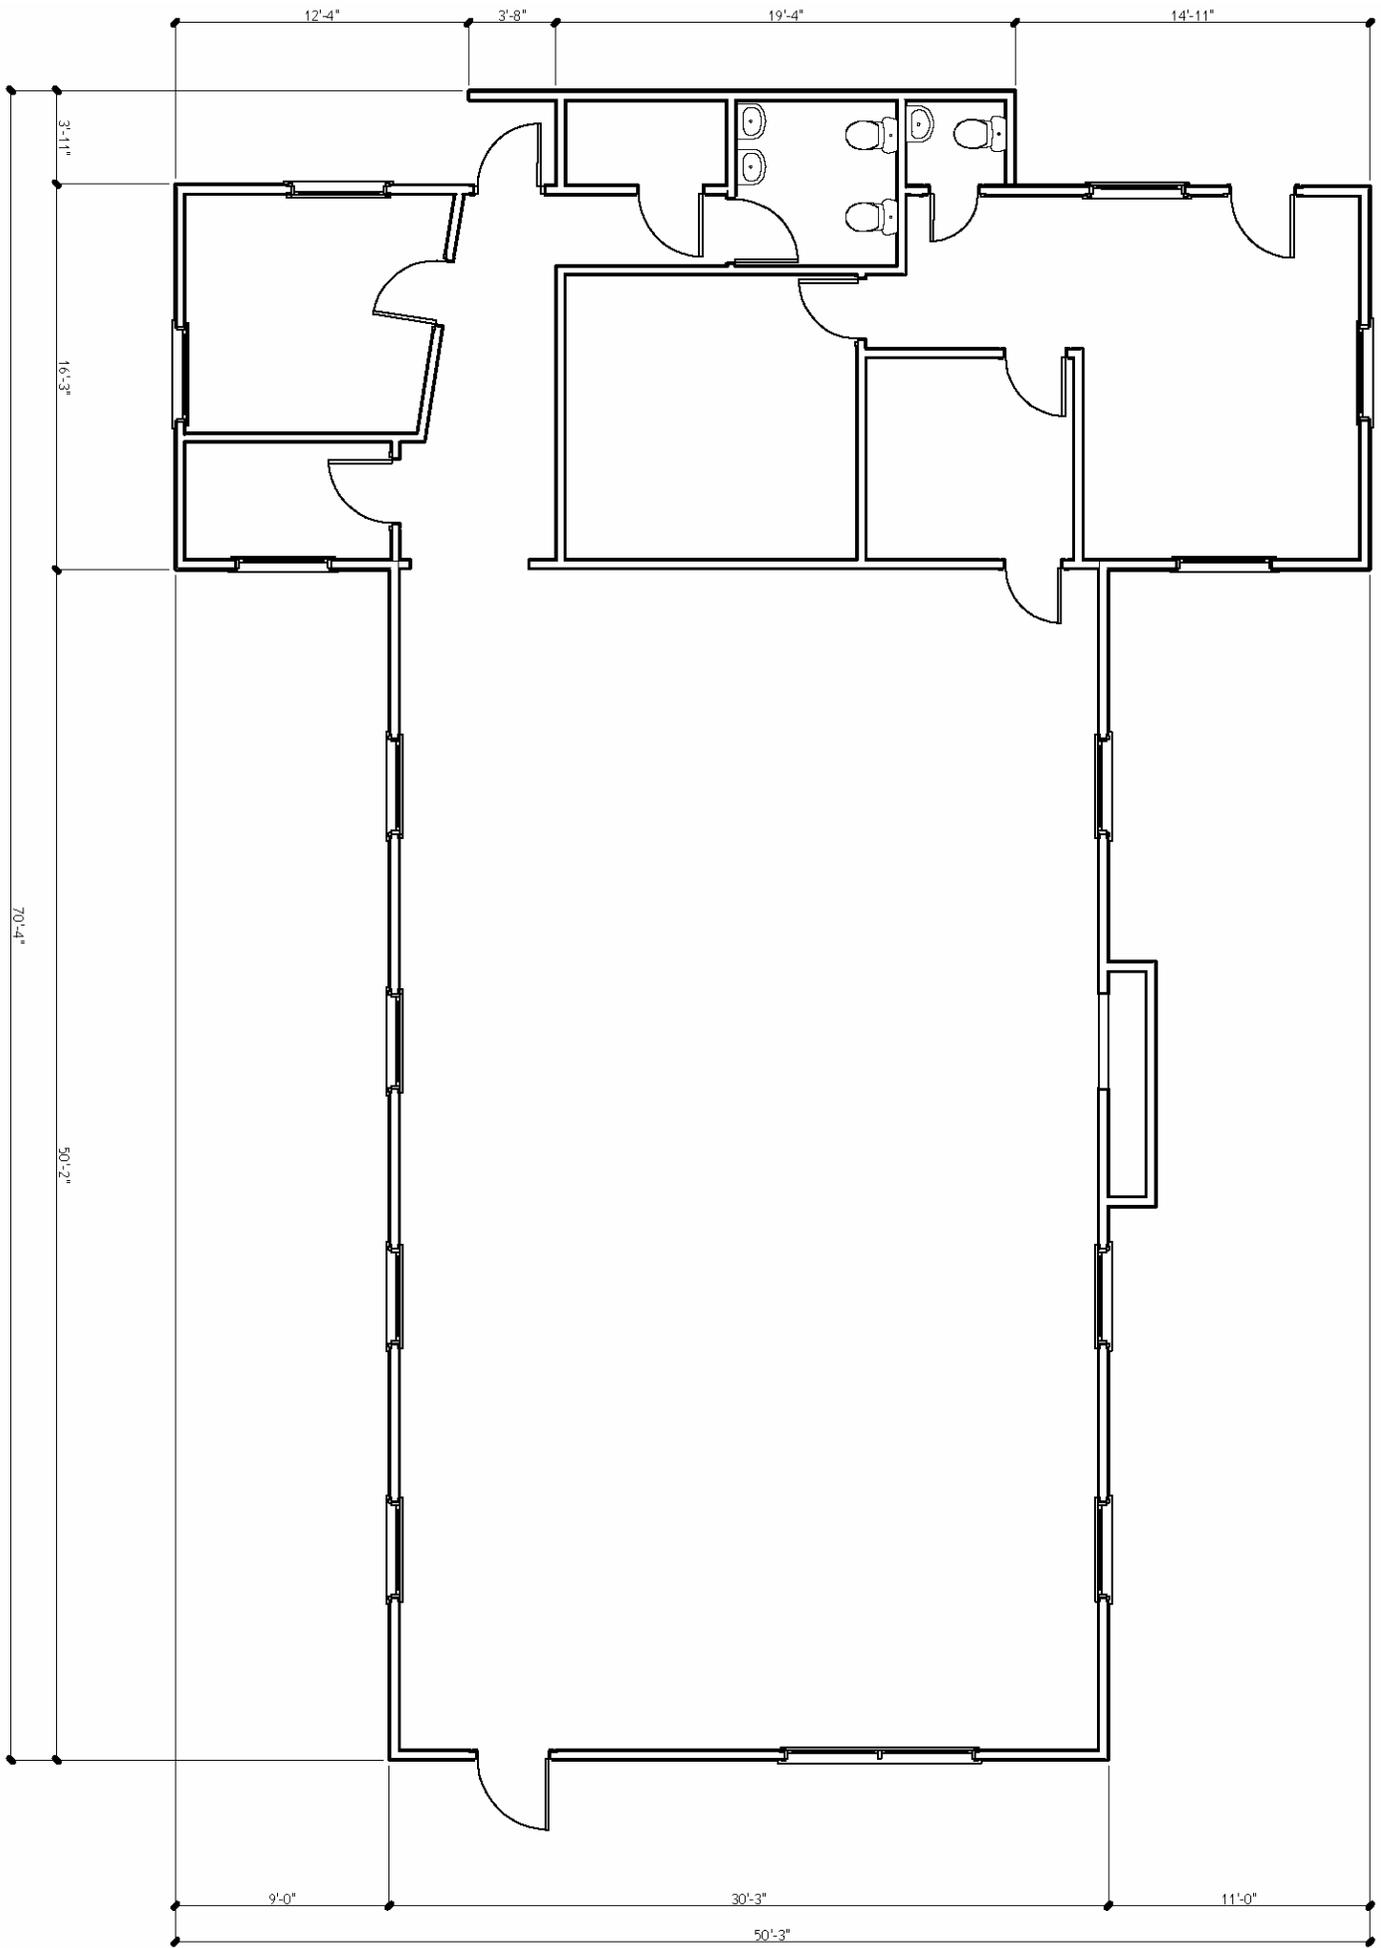
Floor Plan

The Women's Club is a one-story wood framed building with a "T" shaped floor plan. The plan reflects the two construction phases that resulted in the building seen today. The original building, constructed 1919 according to a cornerstone in the foundation, includes the Main Hall and measures about 30 feet by 50 feet. A later addition across the back, measuring about 50 feet by 16 feet, forms the cross of the "T". The date of the addition is not known, but from the materials and details used appears to date prior to World War II.

The building is of light wood-frame construction consisting of widely spaced studs or posts carrying 2 x 4 cross-girts covered with vertical board-and-batten siding. The Club is built over a raised crawlspace on a concrete strip foundation. The roof is also wood framed in a cross-gable form. The roof pitch is about 5:12. There is an overhang of about 3 feet on all sides. The finished floor elevation is about 16 inches above grade on the south side of the building. The top plate of the walls is about 9'- 4" above the floor. The addition was built on a wood foundation system on piers in place of the concrete strip footing.

The floor system is lightly framed of 2 x 6 joists spaced at about 24 inches on center, supported on 4 x 6 runners on 2x blocks down to concrete foundation pads. The structure over the main hall is site-built wood trusses at 24 inch centers.

The recommended process for moving the Women's Club building is as follows. The building would be separated into two parts, the original building and the addition. The walls of the addition would simply be cut loose from the original. A temporary wood-framed shear wall will need to be constructed in the back addition where it meets the main hall. Both the main hall and the addition will be jacked up off of their foundations and steel moving carriages will be constructed under them. After towing to their new location, new foundations will be constructed under the building to match up with required structural support points. When the building is partially supported by the new foundations, the undercarriage can be removed and the remainder of the foundation can be completed.
